Cold Spray Process Development for the Reclamation of the Apache Helicopter Mast Support

by P. F. Leyman and V. K. Champagne

ARL-TR-4922 August 2009

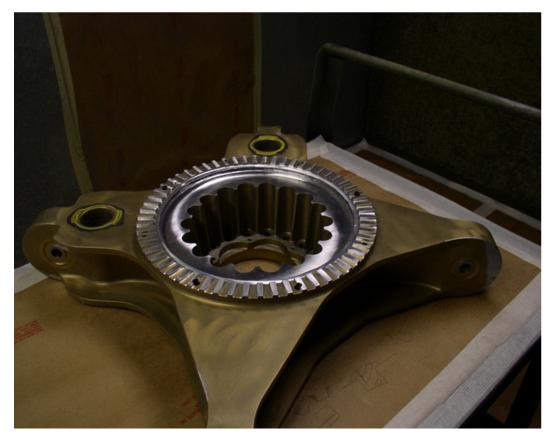
Currently, there are 50 helicopter mast supports that are unserviceable with no viable means to repair the component for service. ARL was requested to perform spray trials on a test section of an Army mast support and then provide technical support to the Aviation and Missile Research, Development and Engineering Center (AMRDEC) to perform the cold spray demonstration on an actual component at Dyn-Corp in Killeen, TX, to assess the feasibility of restoring an unserviceable component to service. This repair effort focused on three types of damage—corrosion pits along the lower lip of the snap ring groove, mechanical damage on the upper lip of the snap ring groove, and mechanical damage to the gear tooth. A helicopter mast support is shown in figure 1.

Figure 1. Aluminum helicopter mast support.

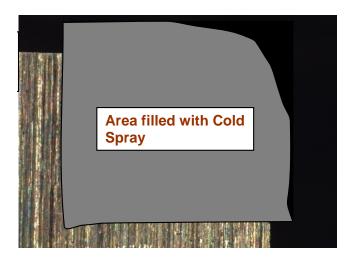
Figure 9. Area filled with cold spray material.

Figure 7 shows the second type of repair that would be performed on the mechanical damage. To demonstrate this repair, the entire snap ring groove area would be removed, as shown in figure 8. The damaged region cross section is completely removed (figure 8), the cold spray material is deposited on the entire area (figure 9), and then it is contoured by re-machining to the original shape and dimension (schematically depicted in figure 10).

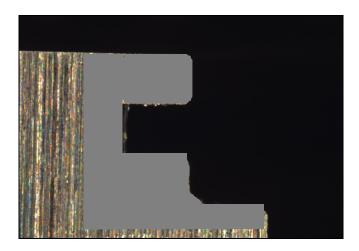
Figure 10. Cold spray material machined back to the original dimensions.

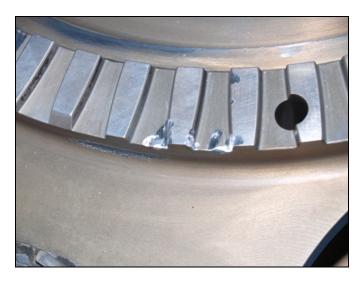
An additional area where mechanical damage occurs is on the splines, as shown in figure 11. To demonstrate the effectiveness of the cold spray repair method, a section of the spline was mechanically removed using a milling machine, filled in using cold spray, then contoured via remachining to the original dimensions.

Figure 11. Mechanical damage to the splines on the Army helicopter mast support.

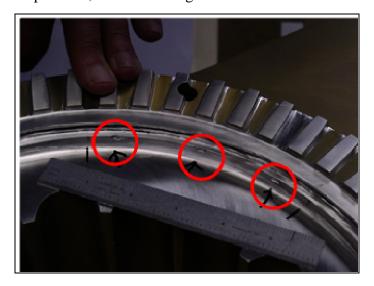
Figure 25. Corrosion pits in lower lip of snap ring groove before cold spray.

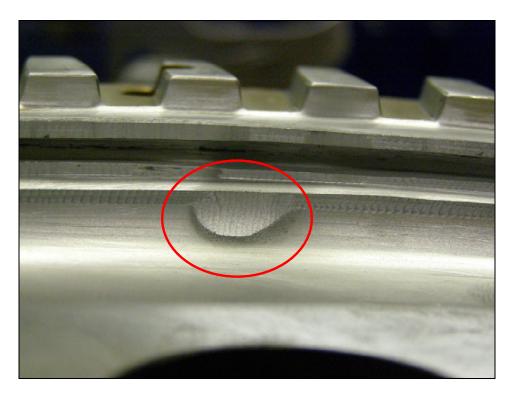
Figure 27. Close up of a corrosion pit filled with cold spray aluminum, machined back to the original dimensions.

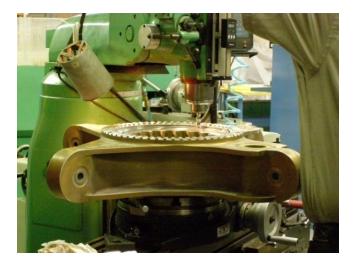
Figure 31. Machinist performing re-contouring of the cold spray aluminum repair to the original dimensions.
